Manhole Inspection Summary

Manhole # S41AA_022MH

Insp Date: **11/11/08 3:00 PM**

Location Address: **1303 e monument st**

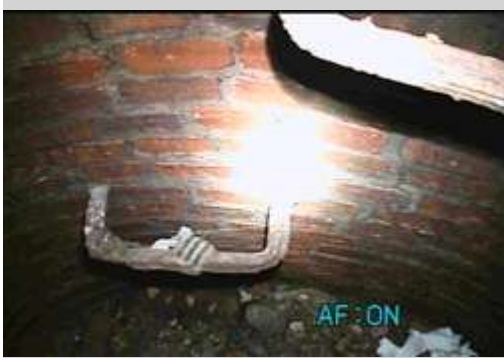
Defect 3

☒ **Evidence Of Surcharge** Depth: **2.** (ft.) ☐ Active Surcharge Present

sucharge evd

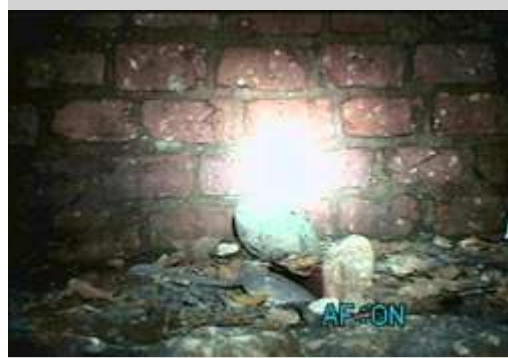
Defect 2

Condition: ☐ Sound ☐ Cracked ☐ Root Intrusion ☐ Deteriorated ☐ Leaks ☒ **Debris**

bench debris

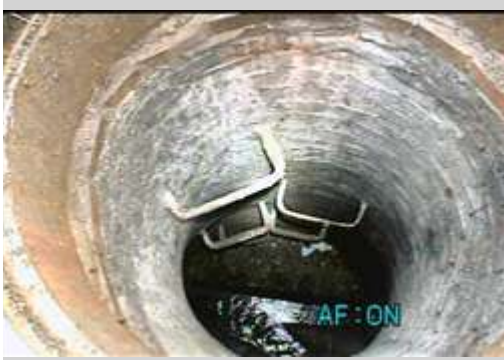
Defect 1

Count: **5** Missing: **0** ☒ **Corroded**

steps corroded

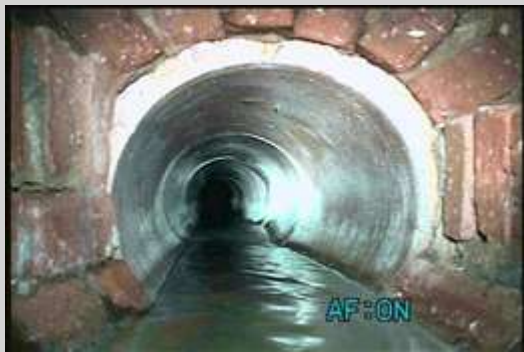
12 O'Clock Outflow

10 in. Circular Gravity Sewer
Pipe Out @ 12 O'Clock

Invert Depth: 10.96 (ft.) Flow Characteristics: Slow

Infiltration: None Pipe Seal Cond: Unknown

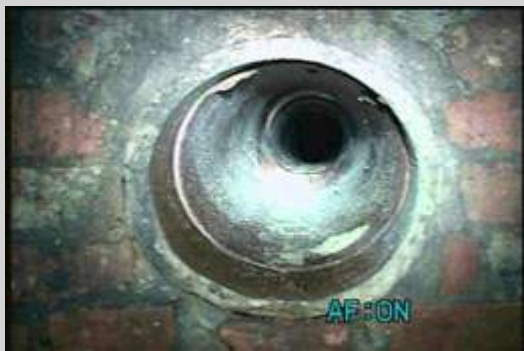
6 O'Clock Inflow

10 in. Circular Gravity Sewer
Pipe In @ 6 O'Clock

Invert Depth: 9.79 (ft.) Flow Characteristics: None

Infiltration: None Pipe Seal Cond: Unknown

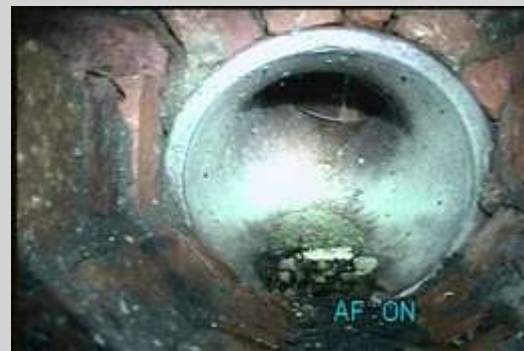
Drop In @ 6 O'Clock

Drop: Outside Direct

Inv Depth: 10.88 (ft.)

Drop Condition: Open

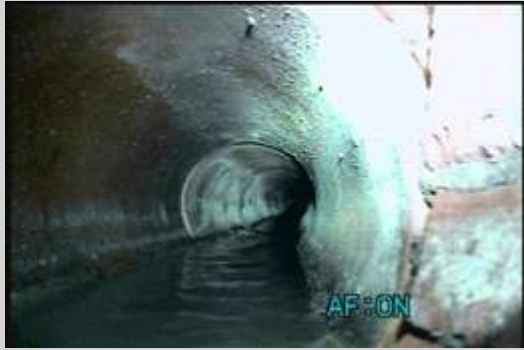
8 O'Clock Inflow

10 in. Circular Gravity Sewer
Pipe In @ 8 O'Clock

Invert Depth: **10.93** (ft.) Flow Characteristics: **Slow**

Infiltration: **None** Pipe Seal Cond: **Unknown**
